US Army Corps
of Engineers

1992 Reservoir Drawdown Test

Lower Granite and Little Goose Dams

APPENDIX H
LEWISTON LEVEE PUMPING PLANTS
1992 Reservoir Drawdown Test
Lower Granite and Little Goose Dams

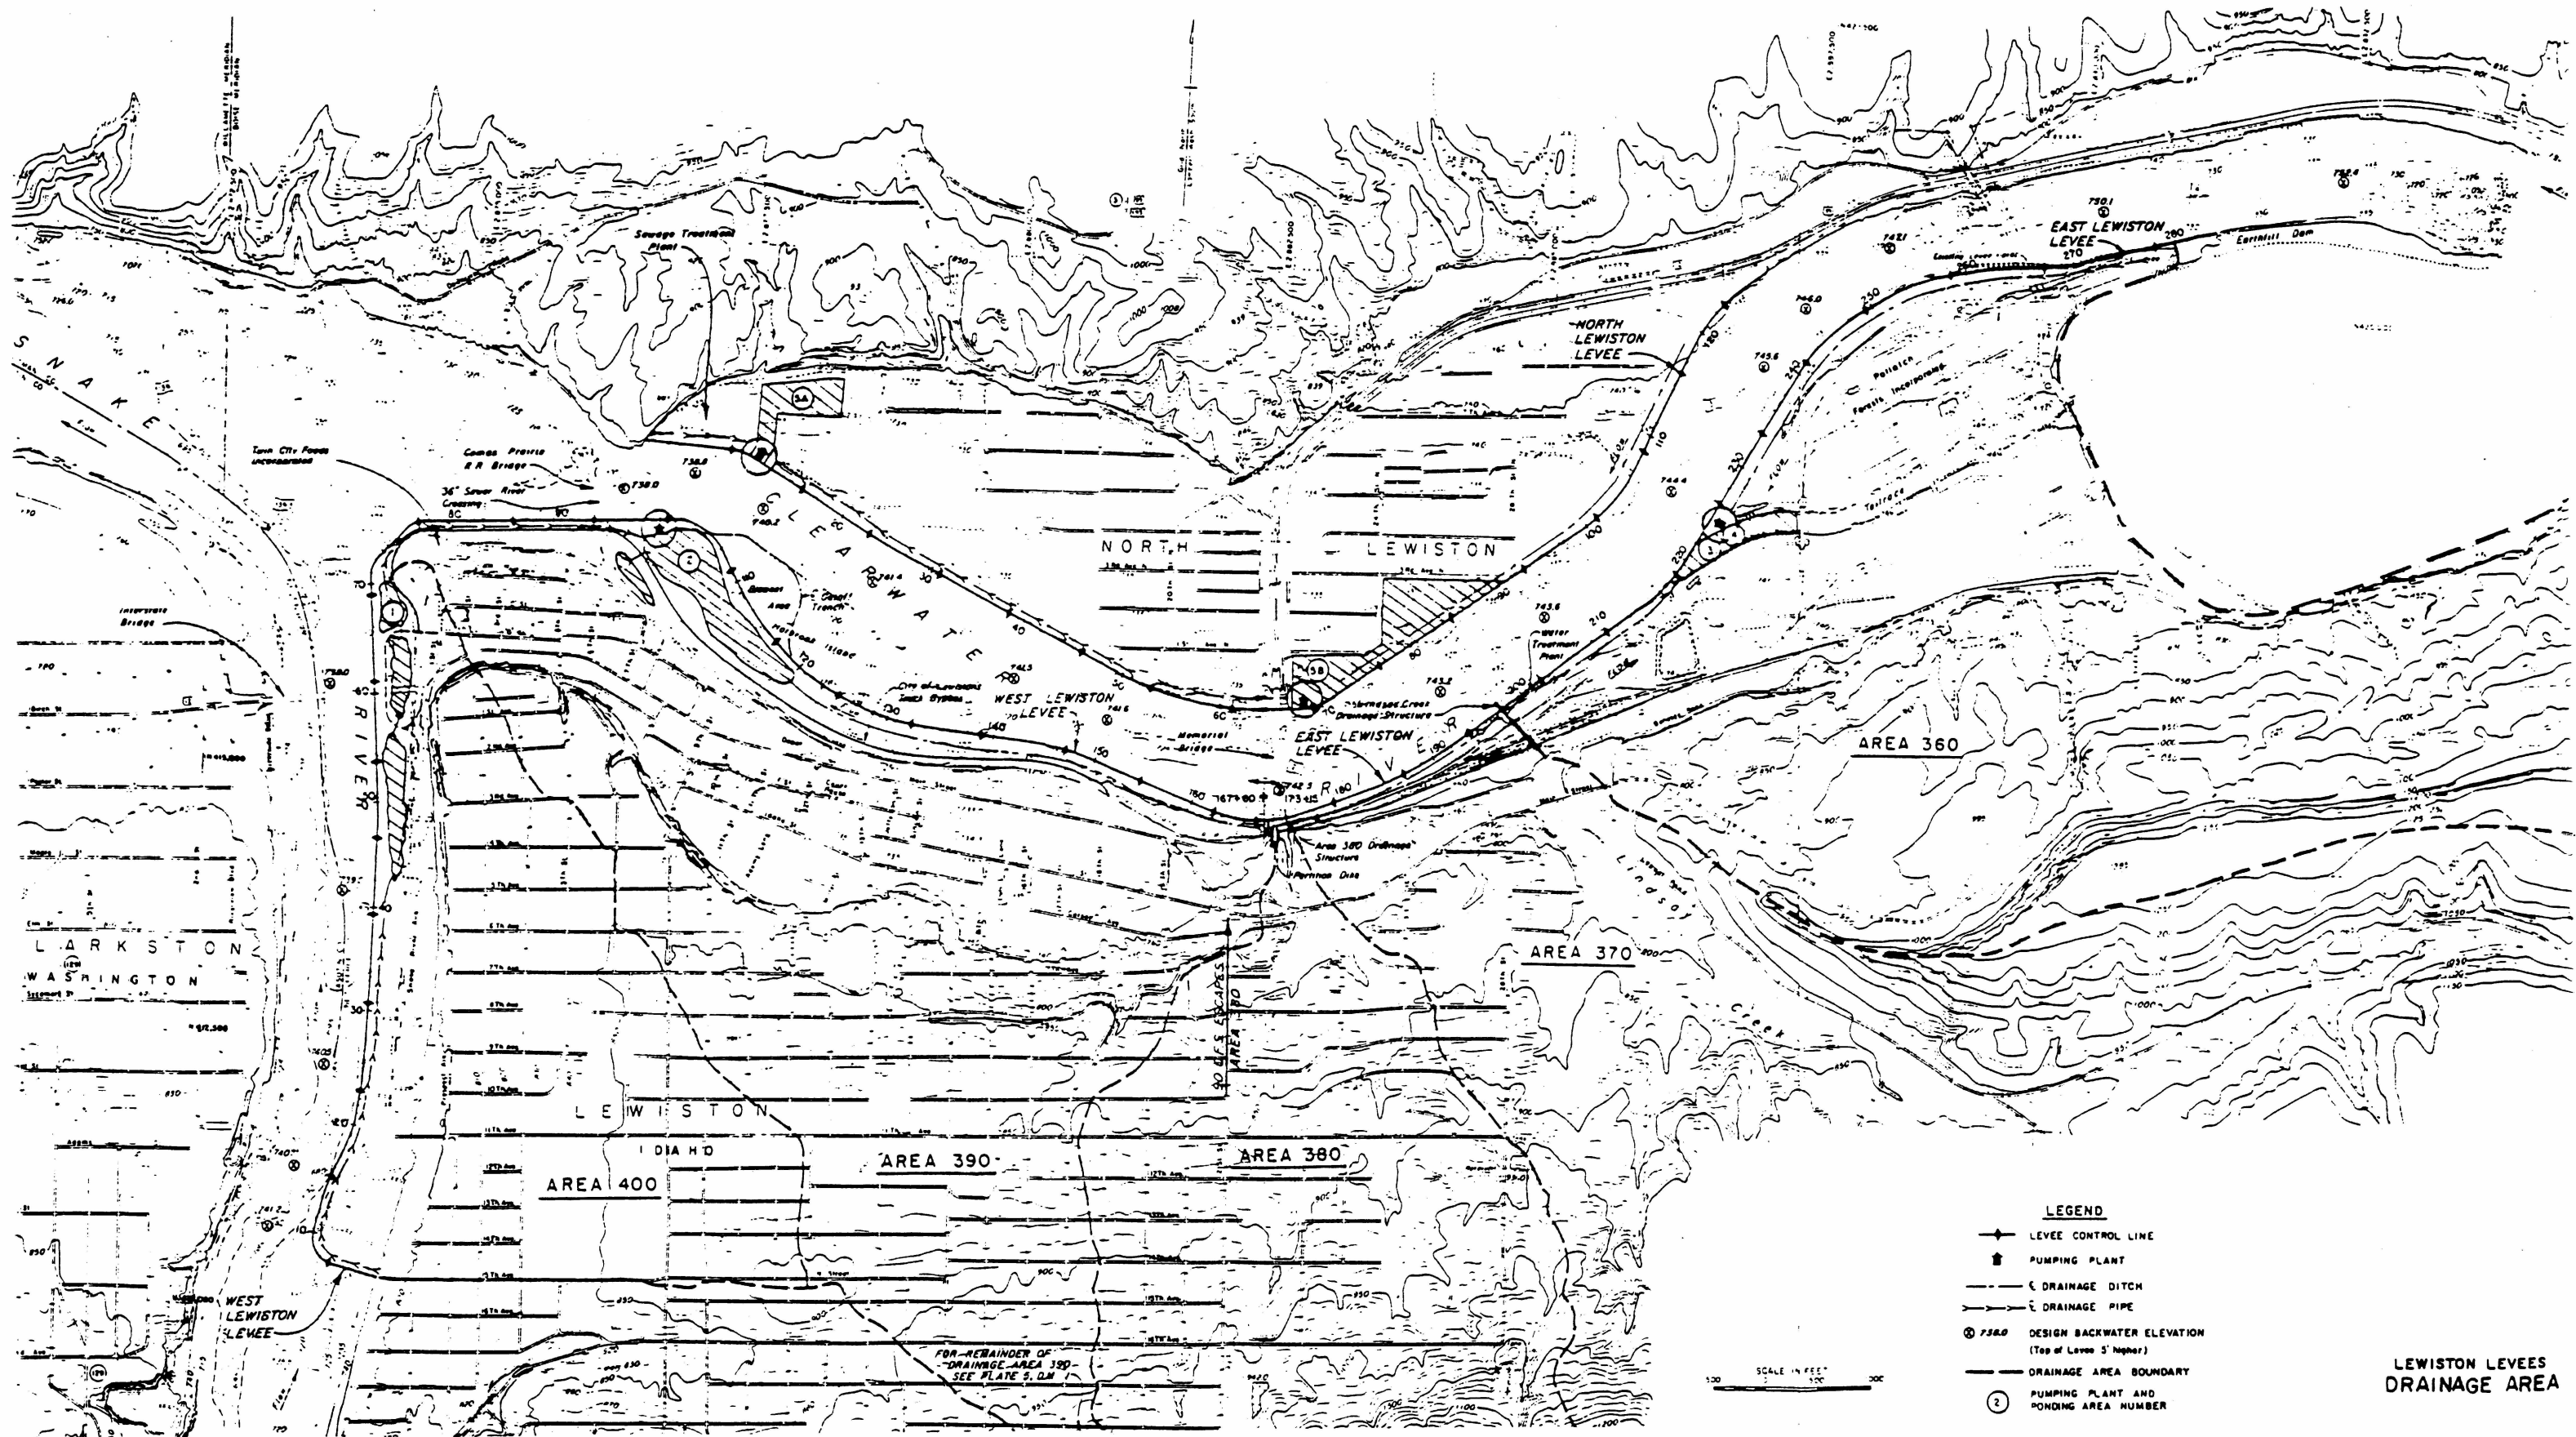
PLATE 2

The West levee pumping plant volume remained at similar levels as the previous year, dipping to a low value of one cubic feet per second (cfs) mid-month, then returning to normal values by the end of the month. The East levee pumping plant volume remained at zero until the end of the month where it rose to 0.69 cfs. This volume probably relates to localized activities at Potlach Corporation. The North A pumping plant volumes were slightly higher than the previous year, dropping continuously until the end of the month, then rising back to pre-drawdown levels. The North B pumping plant volumes remained at similar volumes from the previous year showing a slight dip towards the middle of the month. Plates 2 through 5 shown graphs of the pumping plant volumes with respect to reservoir levels.

The West and North A pumping plants showed similar patterns to the reservoir levels during the drawdown period. The North B pumping plant showed a similar trend, though not as strong. These patterns are attributed to the lowering groundwater levels, hence the reduction in interior drainage behind the levees. The West and North A pumping plants show more pronounced patterns due
